# Manhole Inspection Summary

Manhole # S13II\_023MH

Insp Date: **6/24/09 2:54 PM**

**Location** Address: **1720 DUKELAND ST**

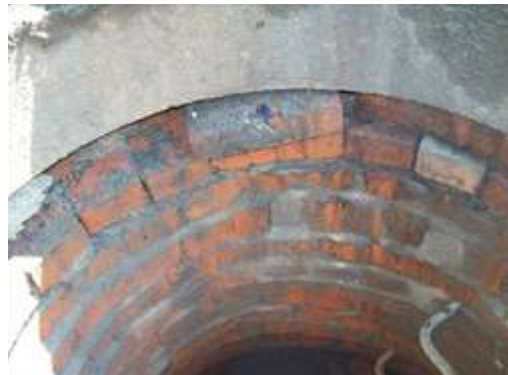
Defect 3

Condition: ☐ Sound ☒ **Cracked** ☐ Root Intrusion ☒ **Loose Brick** ☒ **Deteriorated**

deteriorated

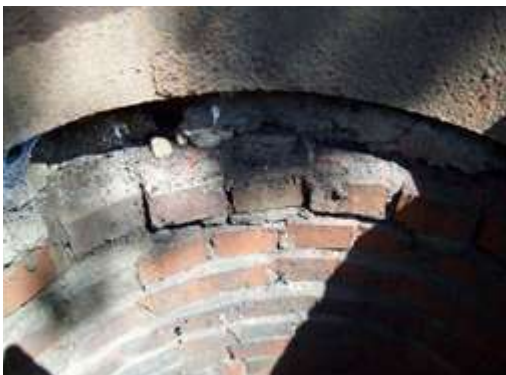
Defect 2

loose bricks at chimney

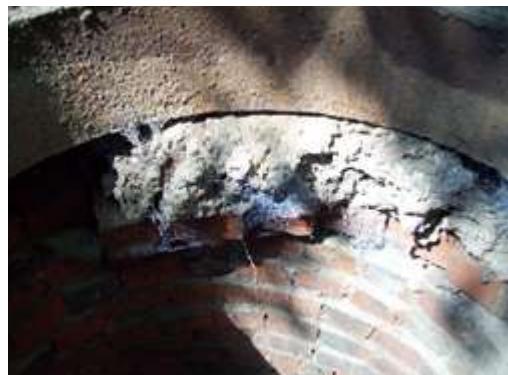
Defect 1

loose bricks at chimney, deteriorated, cracked

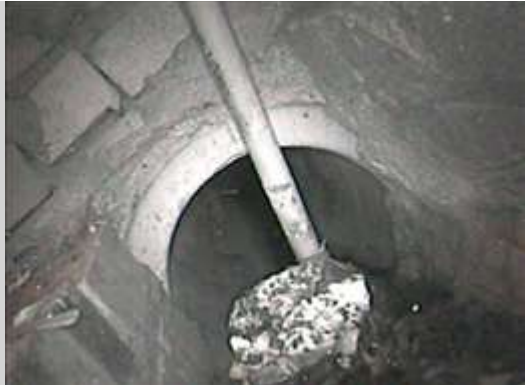
12 O'Clock Outflow

8 in. Circular Gravity Sewer  
Pipe Out @ 12 O'Clock

Pipe Material: **Clay** ☐ Pipe Lined

Invert Depth: **6.92** (ft.) Flow Characteristics: **Slow**

Infiltration: **None** Pipe Seal Cond: **Sound**

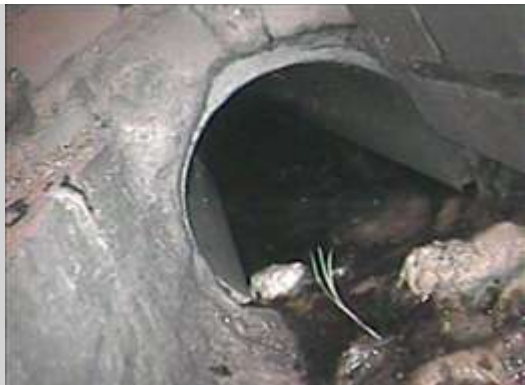
6 O'Clock Inflow

8 in. Circular Gravity Sewer  
Pipe In @ 6 O'Clock

Pipe Material: **Clay** ☐ Pipe Lined

Invert Depth: **6.90** (ft.) Flow Characteristics: **Slow**

Infiltration: **None** Pipe Seal Cond: **Sound**

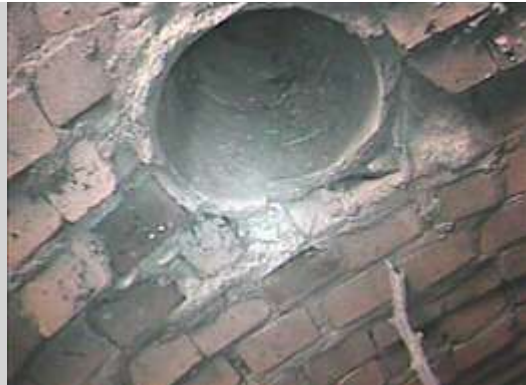
8 O'Clock Inflow

8 in. Circular Gravity Sewer

Pipe In @ 8 O'Clock

Pipe Material: **Clay** ☐ Pipe Lined

Invert Depth: **3.94** (ft.) Flow Characteristics: **Slow**

Infiltration: **None** Pipe Seal Cond: **Sound**

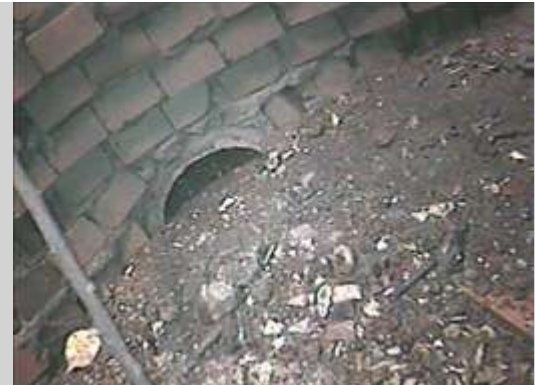
Drop In @ 8 O'Clock

Drop: **Outside Direct**

Inv Depth: **6.67** (ft.)

Drop Condition: **Open**

Connects To: **Stub connection / abandoned**
